Final **DECISION DOCUMENT UST SITE 211**

117th Refueling Wing Alabama Air National Guard Birmingham Airport Birmingham, Alabama

January 1997

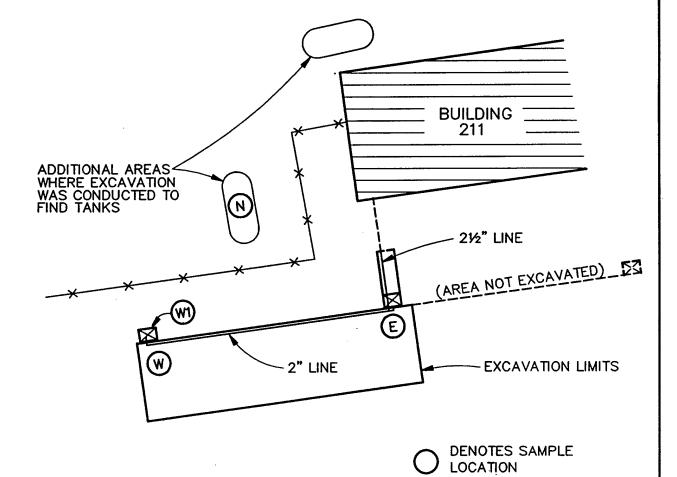
FIGURE 3
UST 211 SITE MAP
Alabama Air National Guard, Birmingham, Alabama

Excavation for the tanks was performed in January 1991. The asphalt and concrete were removed and soil was excavated to a depth of 5.5 feet, to the top of the shallow rock formation. There was no indication of tanks. A 2" diameter line was found on the north side of the excavation and a 2½"diameter fill line was traced and found to extend under Building 211. Additional excavation was conducted on the north and west sides of Building 211 and no evidence of a UST was found. Because shallow rock formations are present in the area, it is expected that the tank was located aboveground.

Three soil samples were taken from the excavations at the UST 211 site. These soil samples did not indicate the presence of fuel component organic compounds. In addition, field screening tests (headspace readings) were conducted with a photoionization detector, manufactured by HNu systems, to screen the soils associated with the fuel systems. Soil samples were placed in glass jars and covered with foil to create a headspace in the top half of the jar. The HNu probe was inserted through the foil cover into the headspace, approximately 5 minutes after sampling, to indicate if any volatile organic compounds (VOCs) were present in the soil sample.

HNu HEADSPACE READING			
LOCATION	(ppm)		
211-N 211-E 211-W 211-SP W-1	5.0 1.2 2.0 - 170

Because no UST was found and soil samples collected did not contain fuel contamination, it is recommended that this site be removed from further IRP activities and that no further action be required.
